Seismic Response Analysis Of Concrete Block Masonry Buildings: An Experimental Study Using Shaking Table

L. Avila, G. Vasconcelos, P.B. Lourenço, N. Mendes & P. Alves

ISISE, Department of Civil Engineering, University of Minho, Portugal.

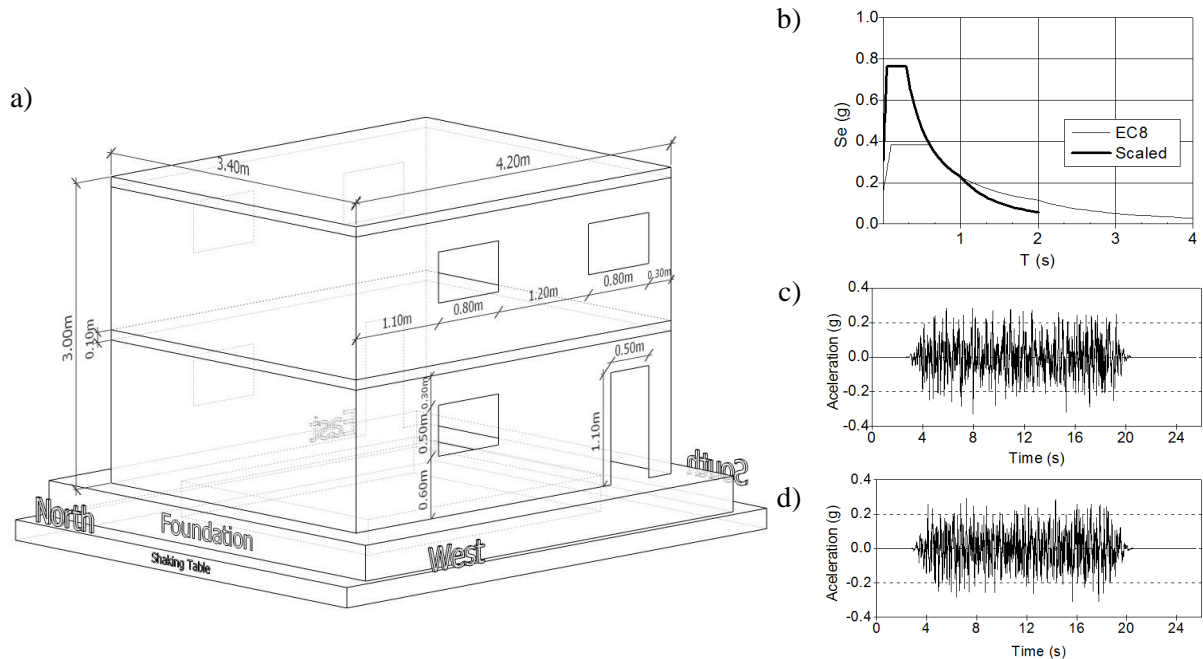
Figure 1. (a) Geometry for RM and UM experimental models; (b) standard and scaled elastic response spectrum; (c) artificial accelerogram North-South direction and (d) artificial accelerogram East-West direction

Cauchy scale law was adopted for the construction of the experimental models and for the input design. Figure 1a shows the final geometry of the scaled masonry buildings. Such a type of scaled models to be tested on a shake table can be used in the case when the stresses induced by the gravity loads are small and negligible with respect to the stresses induced by the seismic forces. This is the case when the lateral load resisting system consists primarily of shear walls.

The tests were developed by imposing simultaneous base excitations, acting along two orthogonal horizontal directions. Two uncorrelated accelerograms based on the type 1 elastic response spectrum for Lisbon zone with ground type A and 5% damping, were implemented, one for each direction respectively. Following the scale law the final response spectrum is show in Figure 1b, and corresponding accelerograms in Figure 1c and 1d. Each building was subjected to a series of dynamic input tests with increasing ground motion, obtained by scaling the accelerograms. The resulting input accelerograms have duration about 17s and spectral acceleration in the plateau region of about 0.75g.

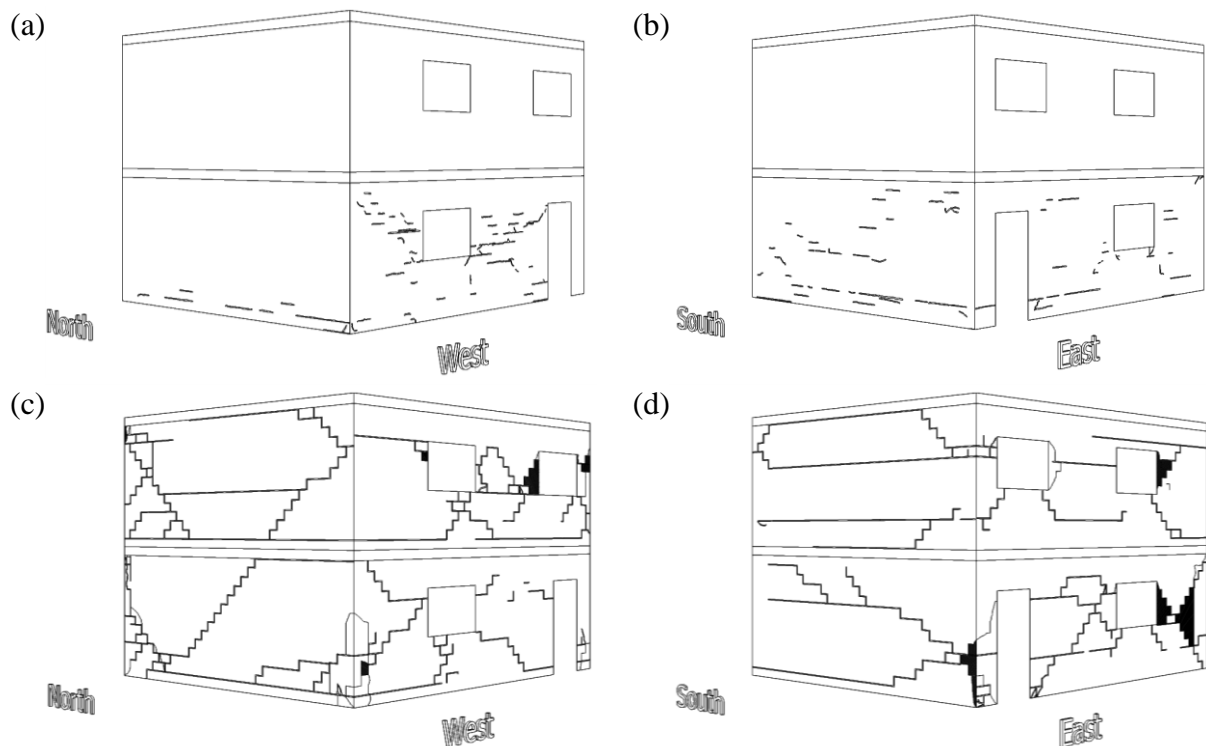
Figure 2. Final damage of: (a, b) RM after 9 test runs; (c, d) UM after 5 test runs

The final damages after an input of 1.61g for RM and 1.33g for UM buildings are presented in Figure 2. It is noted the few damage observed in the RM building after the high strong motion imposed. For this model first cracks appeared after the input test of 100% (0.39g) however it is only until test of 300% (1.33g) that significant quantity of cracks were developed. The model does not present any sign of damage at the second level. The north façade shows only horizontal cracks developed in the mortar joints at the first two rows of units, whereas many smeared horizontal cracks distributed around the

first level wall are found in the south façade, however are also presented similar cracks to the ones observed in the north façade. It was noted that for these two walls 80% of the damaged occurred after the input of 300% (1.33g). In the walls with openings smeared cracks following a diagonal direction within openings are clearly identified. Most of the cracks are horizontal ones at the mortar-unit intersection. It should be mention that the damage in this building started in these walls. This damage is related to the in-plane shear resistant mechanism developed at the first story where stresses are higher due to lateral movements. At the end of the tests maximum crack openings were lower than 1mm.

Major cracks and damages are presented in UM building in which collapse of masonry units were observed at the two levels. For this model significant damage was found at more early stage that the one registered for the reinforced solution. Long horizontal cracks together with stair step ones were found in all walls for the two levels after the input motion of 100% (0.51g). Not small cracks or damage were presented for the test of 50% (0.27g). Most of the stair step cracks started from the windows openings. Subsequence tests developed a mixed in-plane and out-of-plane resisting mechanism of the walls increasing rapidly the initial damages and causes severe horizontal cracks that joined around the whole structure perimeter. This fact develops the separation of the model in well-defined horizontal blocks that promotes sliding resisting mechanisms during shaking tests. Consequently during the final test of 250% (1.33g) several masonry units from two levels started falling out.

As observed the differences in damages between RM and UM models are notorious. The behavior shown for RM building during all the input tests is explained by the contribution of both horizontal and vertical steel reinforcement which increase the connection between structural members. As observed the final condition of this model is very far away from collapse. In the UM building, even the damages were serious, the whole structure did not collapse after and input of 1.33g. The cracking pattern observed for this model differs considerably from the reinforced solution. On it is possible to find clear diagonal cracks that joined with long horizontal ones in both levels. The sliding mechanism generated, increased significantly the displacements of the structure, but at the end of the tests it remains standing. It should be stressed that from the recent past earthquakes, in which masonry

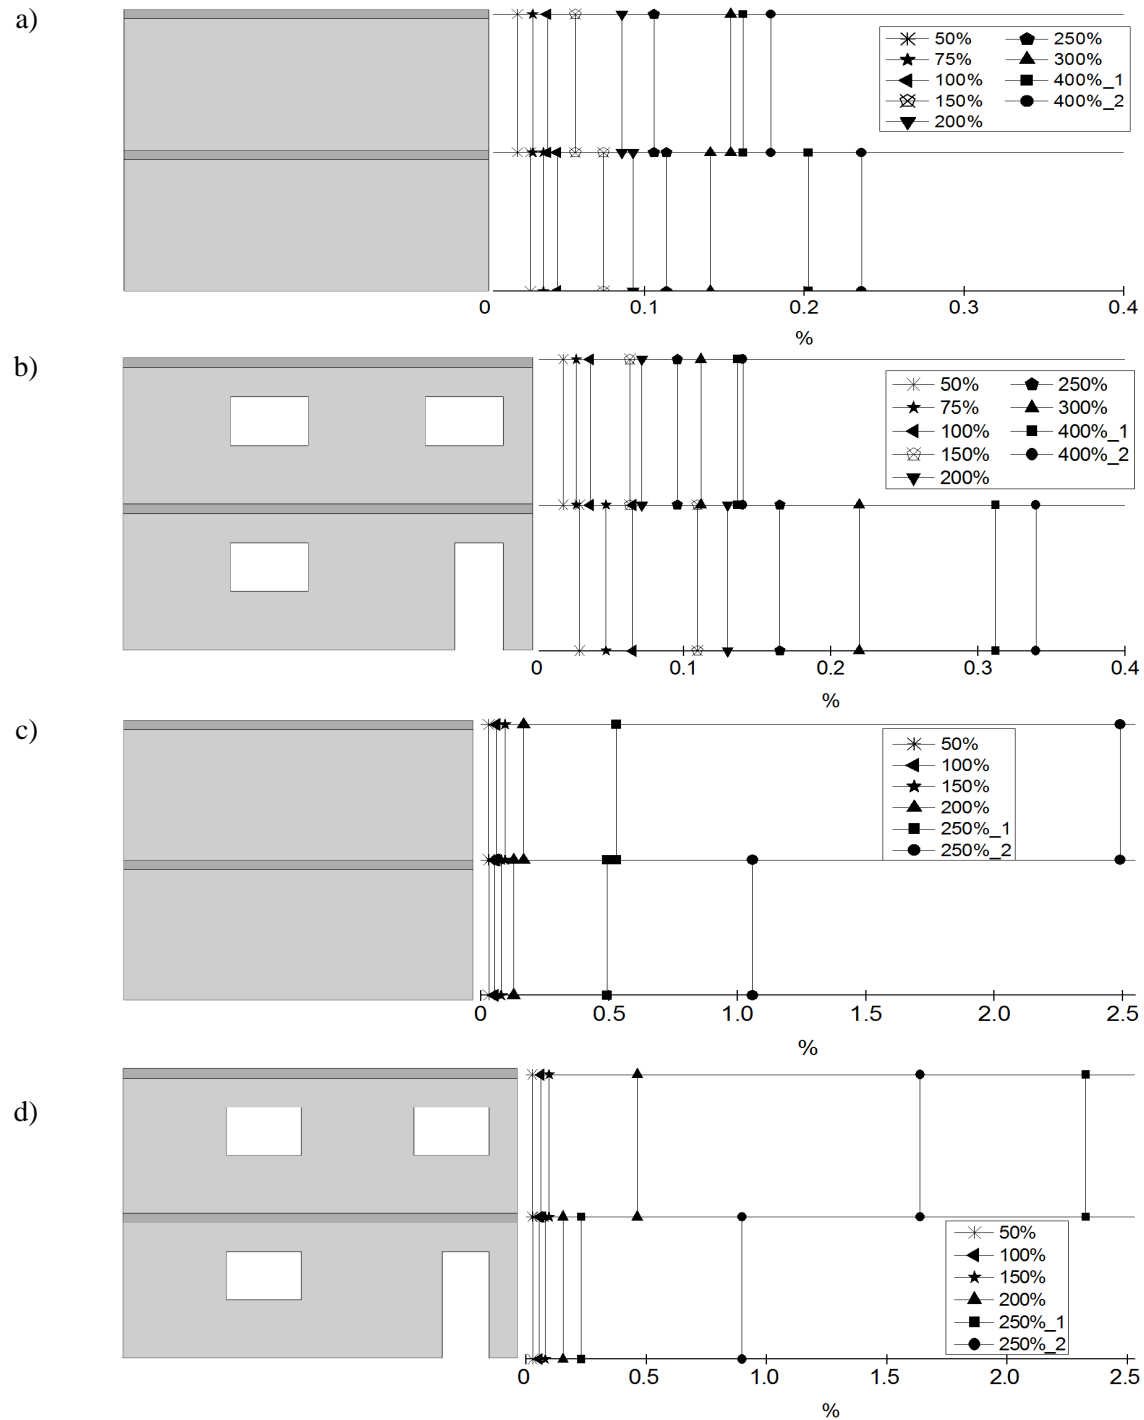
Figure 3. Interstory Drifts: (a,b) RM building and (c, d) UM building

The in-plane behavior of the two structures is analysed in terms of interstory drifts, which is defined as the percentage of the relative horizontal displacement of adjacent floors in relation to its story height. Figure 3 shows the interstory drifts in both directions for the two models.

Results from the RM building show a correlation between the incremental input series and the maximum interstory drift registered in both directions. It is observed that higher values are at the first level as well for both directions with a maximum value of about 0.35% in case of longitudinal walls. Maximum values for the second level are less than 0.18%. The results are in agreement with the damage in the sense that for this model cracks were only noticed at the first level. In general visible cracks are presented when story drift at the first level are over 0.15%.

Opposite situation is found in the UM building. In this model similar behavior was observed in both directions in which maximum interstory drifts were registered at the second level, with a value of about 2.5%, whereas the first level registered a maximum value of about 1%. From the plots it is observed that second's level drifts are higher than the first level ones since the test of 150% in which the maximum base acceleration of the shaking was 0.8g. This behavior is explained due to the accumulated damaged occurred at this stage that caused the development of a sliding mechanism through the horizontal cracks that joined around the perimeter of the building. According with (Magenes and Calvi, 1997) for unreinforced masonry walls the ultimate deformation capacity in shear is very stable when expressed in terms of drift and corresponds approximately to 0.5%. As observed, the damaged presented for the unreinforced building when interstory drifts are about this value is severe, but due to global connection between structural elements given mainly by the mortar and the bond pattern it was possible to attain higher drift without building collapse.

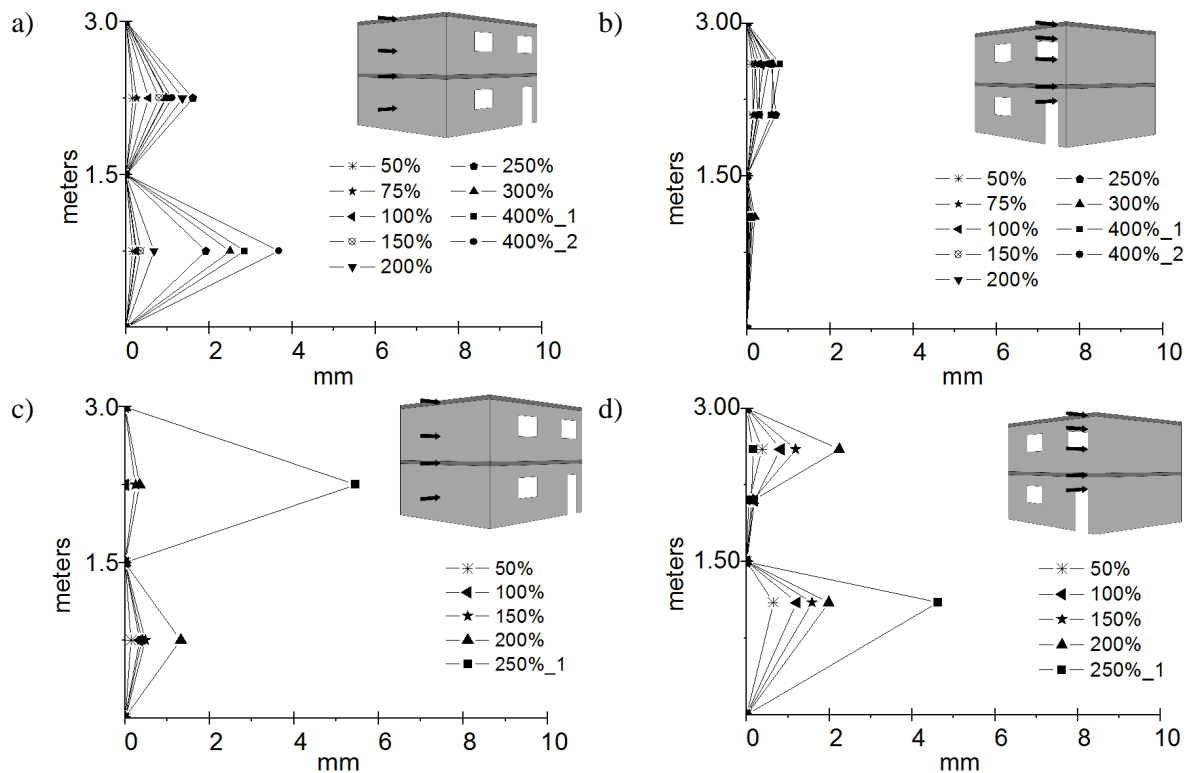
Figure 4. Out of plane displacements: (a,b) RM building and (c,d) UM building

Another important effect studied from the tests was the out-of-plane displacements. As known the vulnerability of masonry to out-of-plane loads can result in the early collapse of structural masonry walls. Figure 4 shows the out-of-plane displacements for both models. Displacements are presented as related to the slabs, in this way the actual out-of-plane displacement carried out by the walls is studied.

The structural behavior of RM building to out-of-plane forces reveals a stiff structure. In the longitudinal direction a maximum of 4mm was registered, as expected according with the damage, it

happened in the first floor. Similar to the interstory drifts, for this level an increase on input motion represent an increase in the out-of-plane displacements. This situation is different at the second floor in which maximum values are less than 2mm. Here, although with small differences, the displacements do not show relation with the increased input sets.

In the transverse direction it was planned to measure the out-of-plane displacements at three different sections, aligned with the windows corners at the two story levels as well as window and door corners. The accelerometers were glued with epoxy resin to the masonry units and some of them felt during the tests, providing incomplete displacement profiles. The less affected cutaway section corresponded with the door opening at the west façade, this section is analysed, even is known that its locations could not be the most representative for the whole wall in which higher displacement would be expected at the middle of the wall length. For the transversal direction of RM building it is observed considerable lower values that the ones registered in the longitudinal direction, with a maximum below 1mm. In general not important differences are found in comparison between two floors. Here it should be stressed that no damage was observed at the right side of the door for this façade, which could explain the results obtained.

As expected higher maximum displacements are found in the UM building. In the longitudinal direction records from the last input test at the first floor could not be measured due to loss of equipment during the test. Maximum value at this floor is about 1.8mm for an input of 1.11g. The second floor attained a maximum out-of-plane value at the last test, input of 1.33g, near 6mm. However previous test presented, with an input of 1.11g, a maximum of 0.3mm, which means a difference of more than 5mm between consecutive tests.

In correspondence with the RM building plots, for UM building was analysed the same cutaway section in the transverse direction. Here a more consistent behavior is found in relation with the inputs in which progressive out-of-plane displacements are presented. The maximum value is about 4.5mm and was recorded at the first level. At the second level the maximum attained a value over the 2mm. The behavior of this model for the out-of-plane displacements is clearly explained for the sliding mechanism occurred and previously mentioned. As observed in recorded videos the sliding behavior was more obvious to happen in the transversal direction. This mechanism could also explain why the small out-of-plane displacements in the longitudinal direction for high input motions. Finally it is important to highlight that for the values found in the proximity of the corner the traditional bond pattern adopted presented an adequate behavior even for large values of seismic loading.

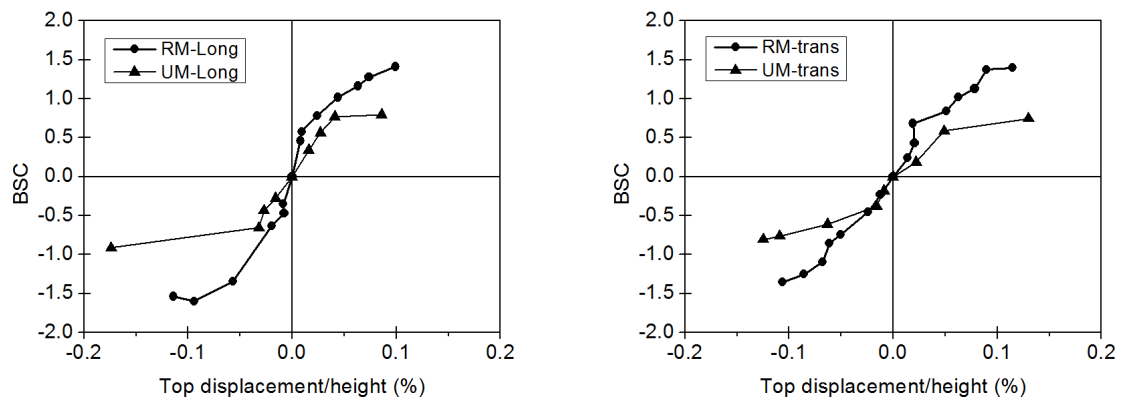
Figure 5. Hysteresis envelopes

The relation between the shear force at the base of the buildings and the global model drift allows a good understanding of the global behavior of the models. Figure 5 shows the monotonic envelopes of the dynamic behavior developed in the models during each individual test run.

The base shear has been calculated as the sum of the inertial forces developed at each story, and is given in terms of base shear coefficient (BSC), calculated as the ratio between the base shear developed in the model during each shaking test (BS) and the weight of the model above the base (W), i.e. $BSC = BS/W$.

From these plots it was evident that the models presented stiffness degradation. Here it is possible to observe how the stiffness of the RM model is higher than the stiffness of the UM building, both in the longitudinal and transversal directions. This behavior is observed since early stages and corresponds with both the higher level of damage and the larger displacements found in the UM building. However a similitude between models is found, on them stiffer behavior is presented in the longitudinal direction.

The comparison between hysteresis loops, from where the envelopes are obtained, for the two models reveals the difference in energy dissipation. The hysteresis loops found for the UM building involves more energy dissipation, particularly in case of the transversal direction, due to the predominance of the sliding mechanism. In comparison between the same input tests the displacements obtained for the UM model are considerably higher than the ones found in RM model. This behavior clearly shows the improvement in resistant capacity, stiffness performance and displacement response given by the steel reinforcement when it is used in masonry structures.

As observed the maximum values of BSC in UM building are less than 1 for both directions, whereas RM building attained values around 1.5, however the results also indicate clearly that the UM model reached the maximum capacity, while the RM model is possibly also rather close to the maximum capacity as some of the envelopes seem to present already a plateau.
